Cloud-Aerosol LIDAR and Infrared Pathfinder Satellite Observation (CALIPSO) Spacecraft

Independent Technical Assessment

The NASA Engineering and Safety Center (NESC)

Report of the ITA Findings to the NESC

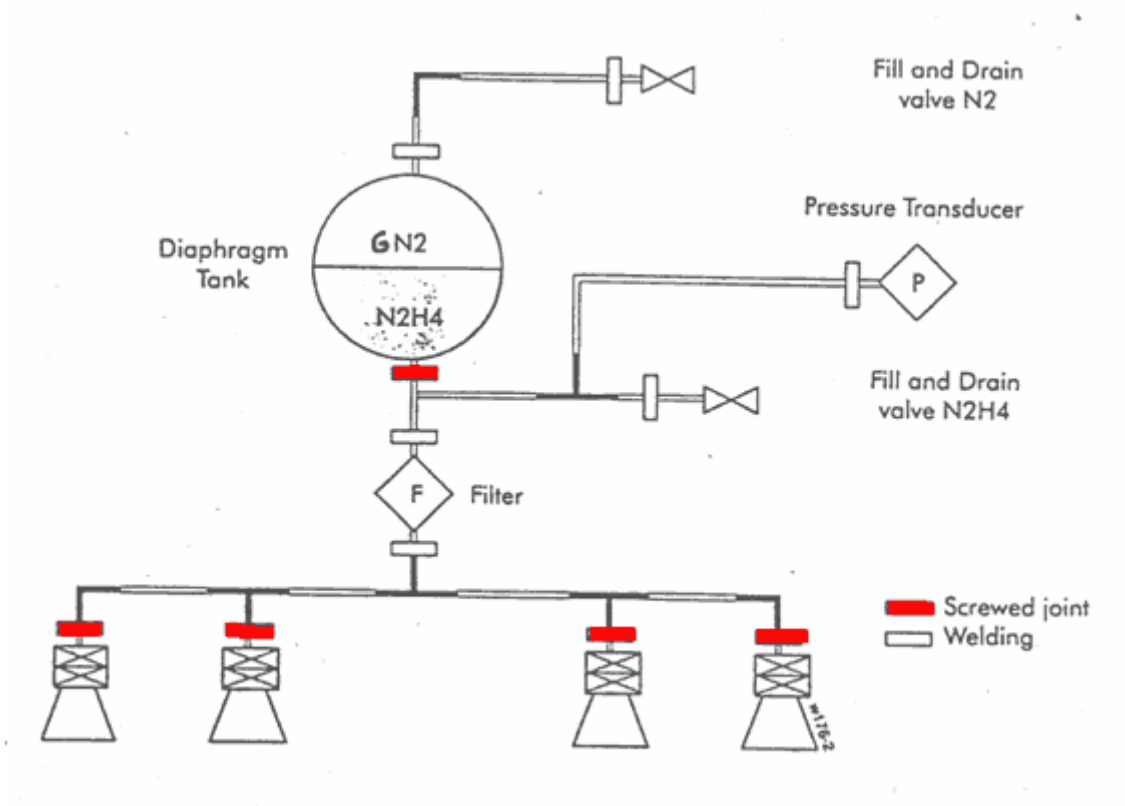
Figure 1. Schematic of CALIPSO Propulsion System

The issues addressed in this assessment involve the Proteus spacecraft bus provided to CNES via subcontract with Alcatel Space Industries. This bus is identical to that flown on the Jason-1 mission launched in December 2001 on a Delta II from VAFB. NASA's Jet Propulsion Lab managed the Jason-1 mission. Issues on CALIPSO are associated with the Proteus hydrazine propulsion system used for orbit corrections depicted in Figure 1. The system has five (5) mechanical MS-33656 37° Army/Navy (A/N) fittings, one located at each of the four (4) 0.225 pound-force thrusters (Astrium model CHT 1N) and one at the outlet of the ten (10) gallon hydrazine tank manufactured by Rafael. All other connections in the hydrazine system are welded.

Three key issues have been highlighted: (1) use of mechanical fittings instead of welded joints for propulsion system fluid connections, (2) the potential for hydrazine leakage through thrusters and (3) the potential for inadvertent thruster firing. Personnel risks associated with these issues are:

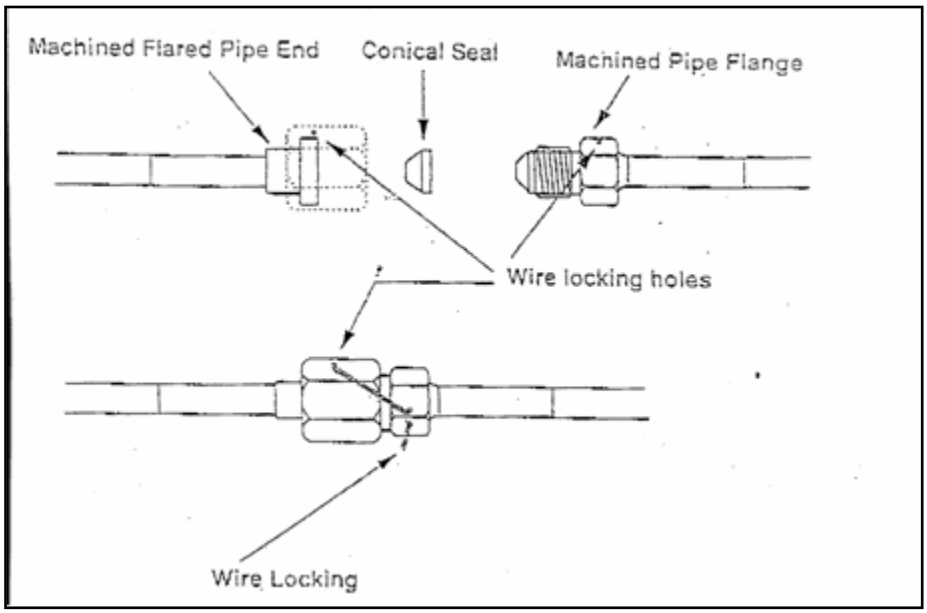
Figure 2. MS 33656 A/N fitting installation detail

Properly welded fluid connections are inherently more reliable than mechanical fittings and should be incorporated in fluid propulsion system designs when possible. There are some circumstances, however, under which mechanical fittings offer an appropriate design solution. Ready interface to off-the-shelf parts, ease of maintenance, or potential for damage to soft goods during welding all may dictate use of threaded joints. MS-33656 type 37° A/N-fittings have been employed successfully in aerospace applications for many years and are acceptable for limited use providing they are (1) properly assembled, (2) validated by leak check as an assembly before use, (3) exposed only to temperature, pressure, vibration and shock environments for which they are certified, and (4) incorporate a secondary locking feature. The Proteus bus uses five such fittings; one at the hydrazine tank outlet and one at each of the thruster inlets (see Figures 2 and 3 for details). While lock-wire is used as a secondary locking feature, it is suitable only for preventing significant rotation of the B-nut and full disengagement of the fitting. Lock-wire alone will not prevent loss of joint preload[8] with subsequent reduction of clamping force at the sealing surfaces, and thus cannot be counted upon to prevent a fitting from leaking.

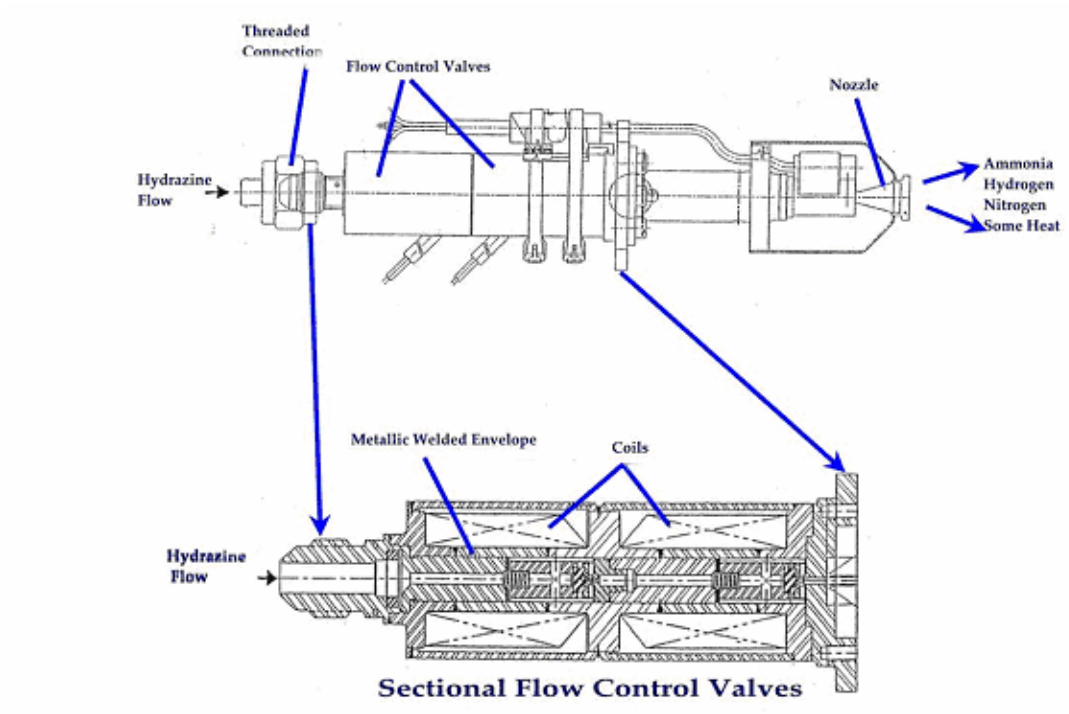
Figure 4. Moog Dual Seat Dual Servo Thruster Valve

Thrusters selected for the Proteus bus are designed with normally closed series-redundant solenoid-actuated flow control valves manufactured by Moog. The thrusters are of a mature design. A schematic of the valve is depicted in Figure 4.

NESC concludes the potential for external leakage from the thrusters either internally (across the control valves) or externally (thruster casing or seal) poses acceptable risk to personnel providing the program conducts an adequate pre-servicing leak check of each valve. While the program did indicate such testing was planned, NESC was not provided a specific description of the test or its pass/fail criteria.

NESC-R-007 – Program shall demonstrate that pre-servicing thruster leak checks will be adequate to validate system integrity. Leak check procedures shall test each valve independently and shall specify test method, equipment to be used, media, test pressure and allowable leak rate.

NESC-R-008 Program shall verify that the Proteus Moog valves on CALIPSO do not have defective plunger assemblies.

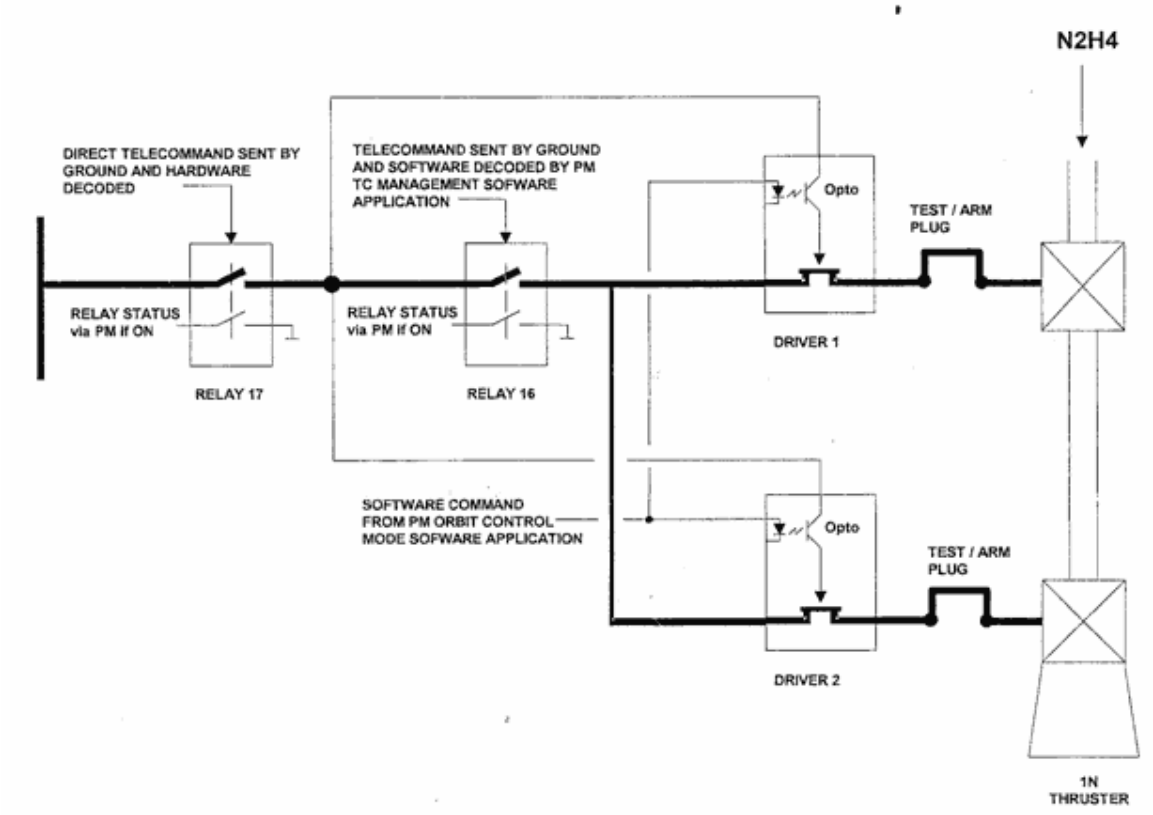
Figure 5. Thruster Circuit Schematic with New Test/Arm Plugs (PM refers to spacecraft processor module)

The Proteus thruster firing circuit incorporates a number of controls to ensure valves are not inadvertently opened causing a thruster to fire. NESC concurs the controls are adequate, but recommends further steps be taken to positively preclude the possibility of an inadvertent command during periods of dynamic testing, especially power-up. A schematic of the thruster wiring circuit is shown in Figure 5. It is worth noting that the Astrium specification sheet for the thruster lists nominal flow rate at 0.44 grams per second. Even with all four (4) thrusters firing at nominal flow rate, it would take 4.7 hours to drain the 30 kilograms of hydrazine in the propellant tank.

NESC-R-009 – Program shall demonstrate that test procedures verify relays 16 and 17 are open before power is applied to the spacecraft. Since the design incorporates latching relays, verification of the last stable state by data retrieval or written record is acceptable.

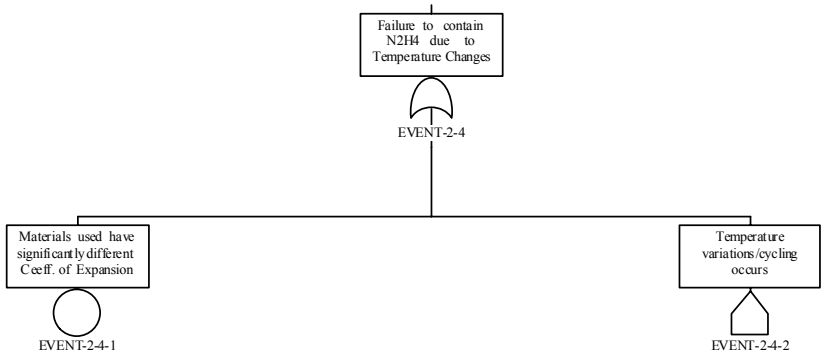
Failure to contain N2H4 due to Temperature Changes
EVENT-2-4
Materials used have significantly different Coeff. of Expansion
EVENT-2-4-1
Temperature variations/cycling occurs
EVENT-2-4-2

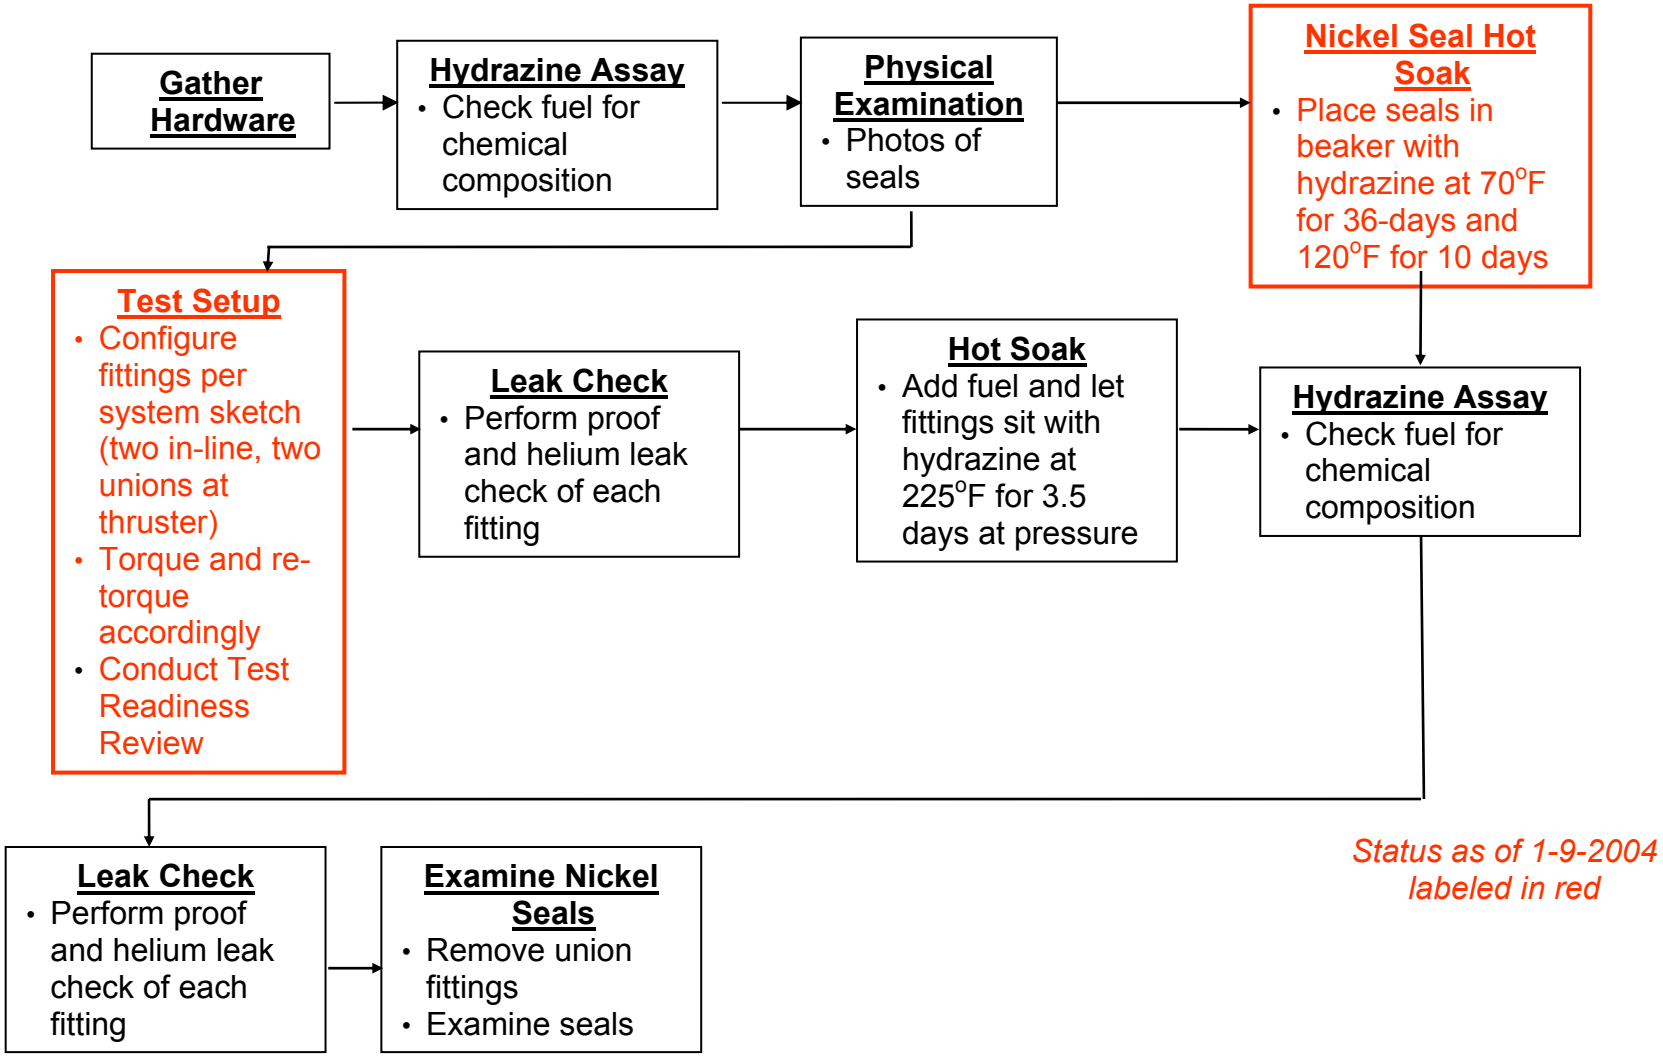
Propulsion System Schematic for Test

Status as of 1-9-2004 labeled in red

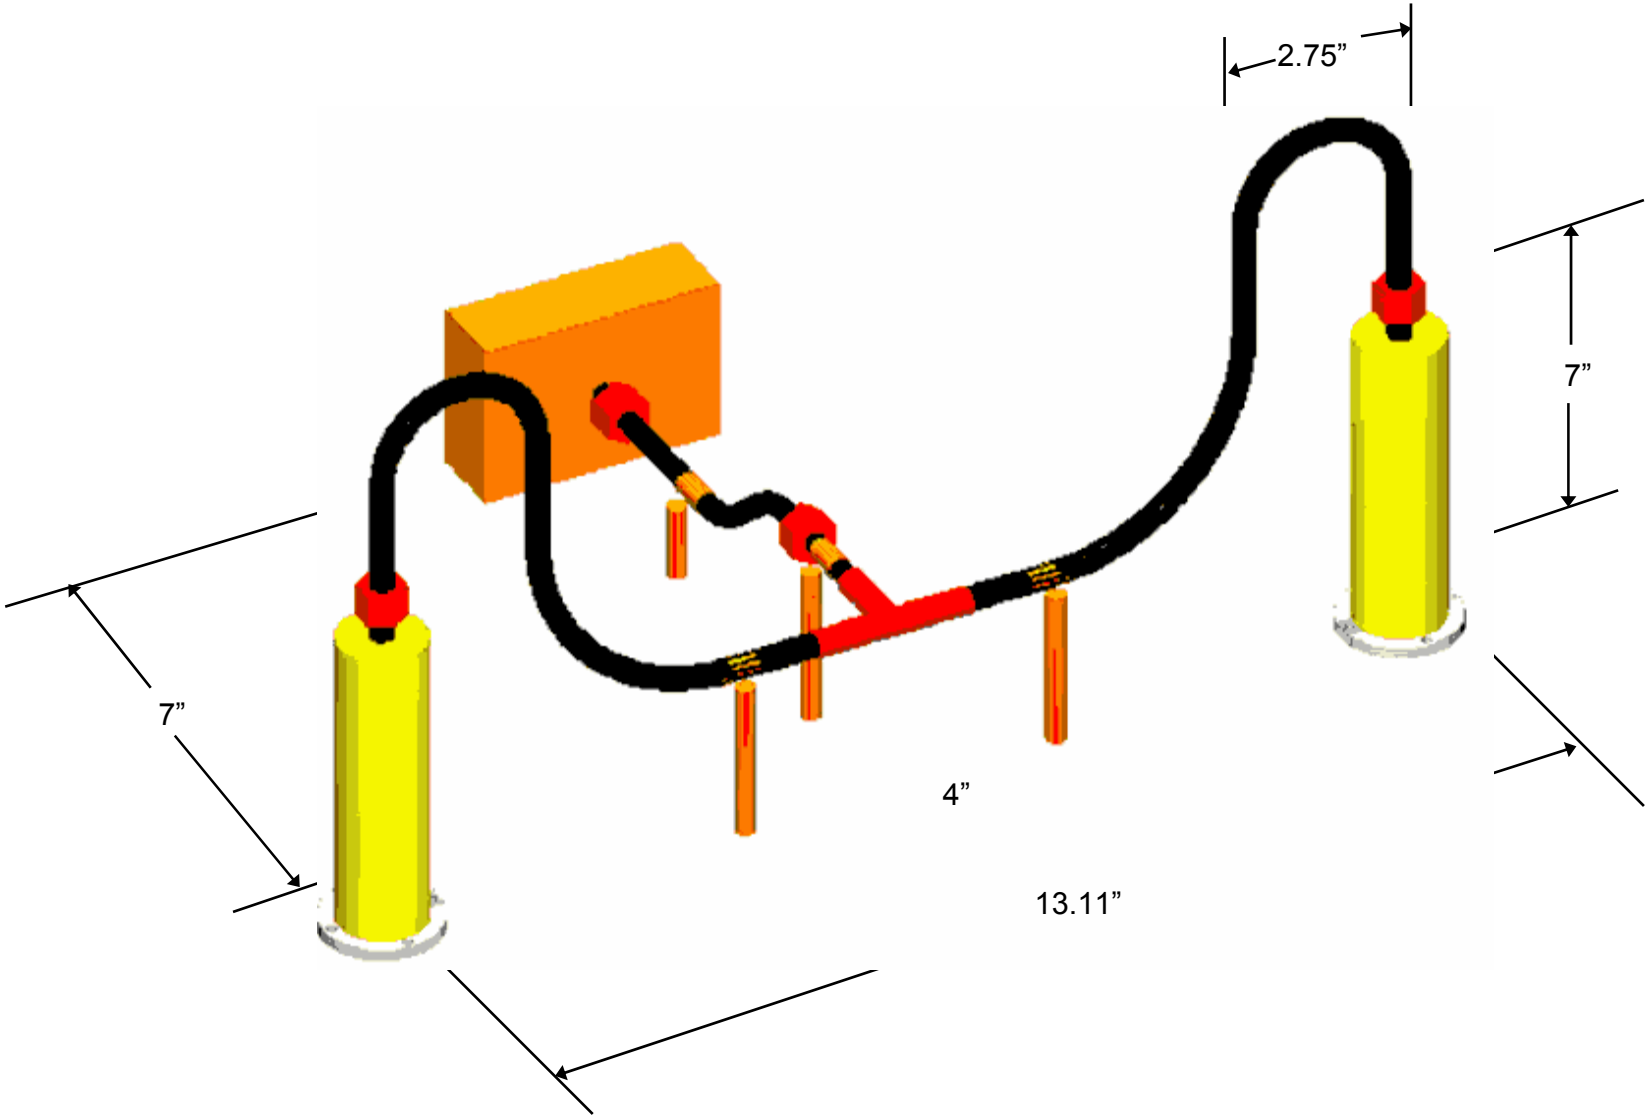
Hot Soak Test Setup

- **Four fittings to be tested: Two in titanium line, and two CRES at thruster location**
  - **Thruster fittings simulated for hot soak test due to the uncertainty of the valves acquired. Valves need to function properly when exposed to hydrazine for decontamination purposes.**
- **Lines filled with hydrazine and stored in oven**
  - **Temp at 225°F; Line pressure at 320 psig; Duration of 3.5 days**
